Road and Railroad Crossing Inventory

Starkweather Coulee

U.S. Department of the Interior
Bureau of Reclamation
Great Plains Region
Dakotas Area Office

October 2004

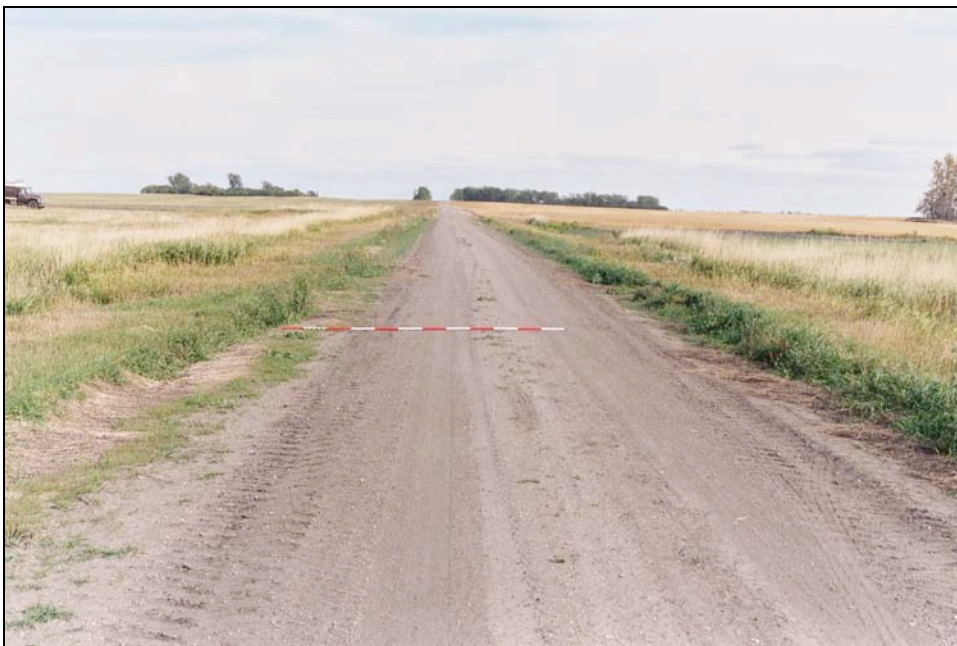
S46 Center of road crossing across two CMP & one concrete pipe, looking east (09-30-04), Section 24 & 25, T161N, R64W, N 641434.23, E 2393086.40, elevation 1611.8 @ center of road crossing, top of ground.

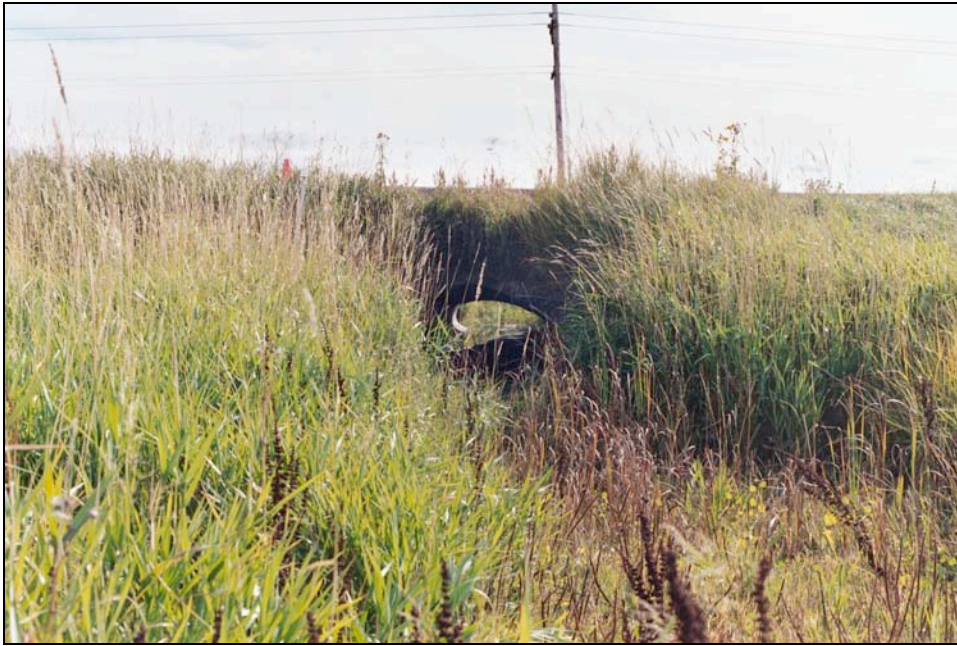
S47 Upstream side one 48" CMP & one 24" concrete pipe, in good condition, no water, west to east (09-30-04), Section 13 & 24, T161N, R64W, N 646698.92, E 2390960.29, elevation 1608.6 @ invert of 48" CMP, N 646702.54, E 2390997.47, elevation 1609.7 @ invert of 24" concrete pipe.

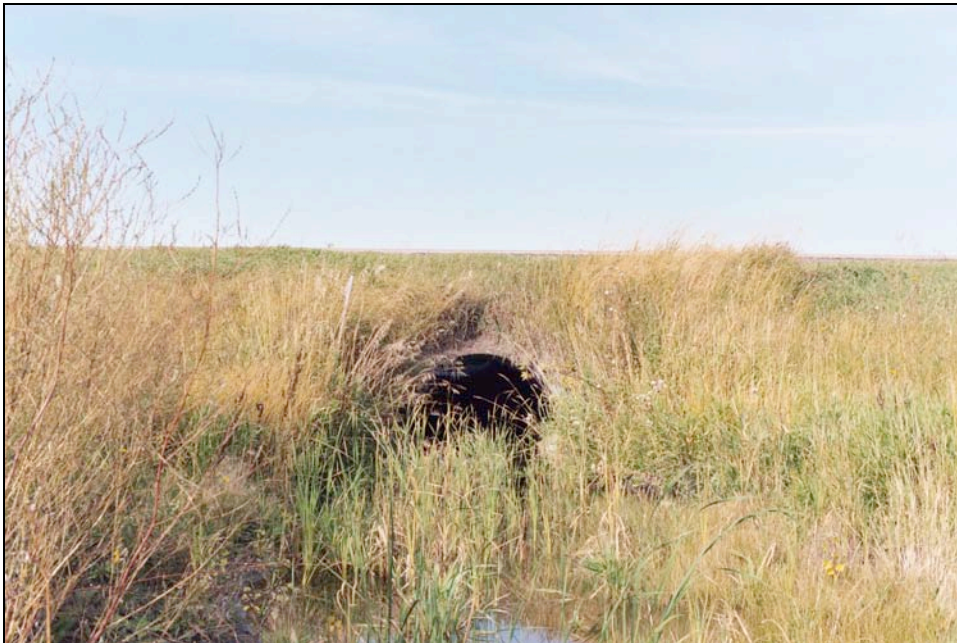
S47 Downstream side one 48" CMP & one 24" concrete pipe, in good condition, no water, east to west (09-30-04), Section 13 & 24, T161N, R64W, N 646646.31, E 2390961.54, elevation 1608.3 @ invert of 48" CMP, N 646646.65, E 2390998.83, elevation 1609.8 @ invert of 24" concrete pipe.

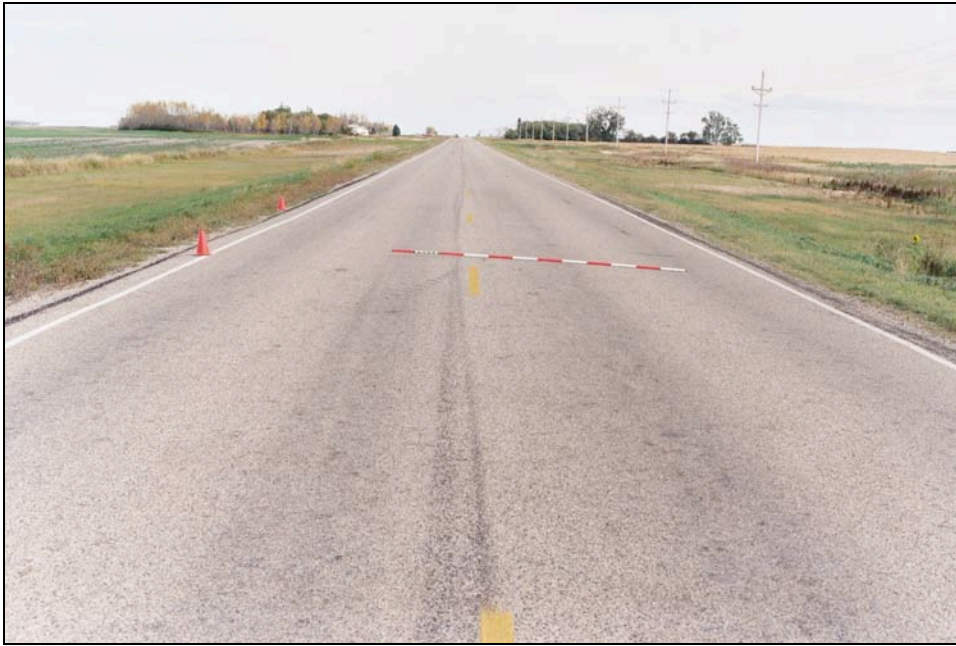
S47 Center of road crossing across one 48" CMP & one 24" concrete pipe, looking east (09-30-04), Section 13 & 24, T161N, R64W, N 646674.22, E 2390962.96, elevation 1616.1 @ center of Hwy 5, top of asphalt.

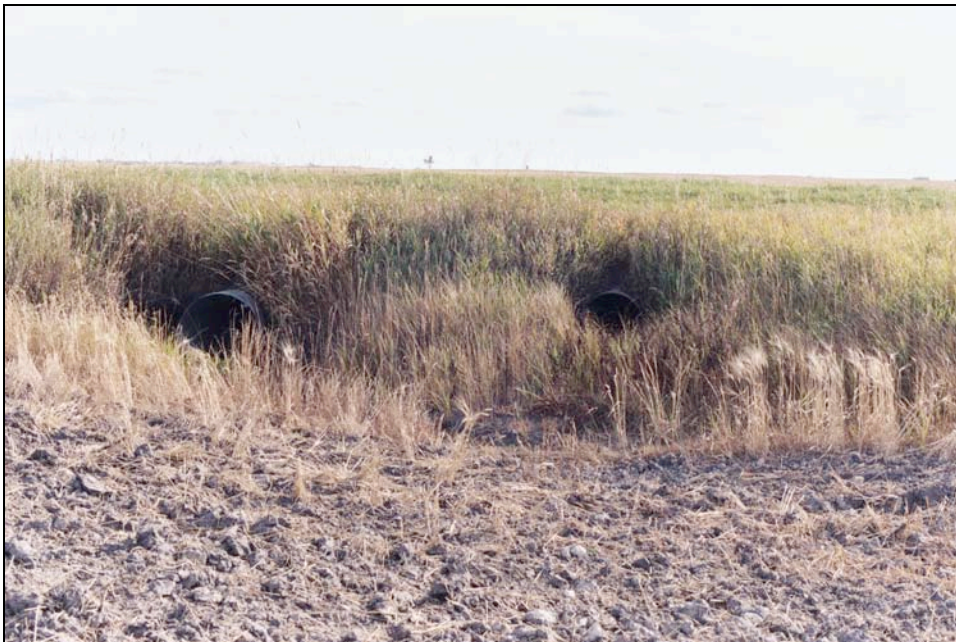
S48 Upstream side on one 24" & one 36" CMPs, in good condition, no water, west to east (09-30-04), Section 12 & 13, T161N, R64W, N 651953.31, E 2389331.02, elevation 1611.1 @ invert of 24" CMP, N 651955.07, E 2389344.35, elevation 1609.7 @ invert of 36" CMP.

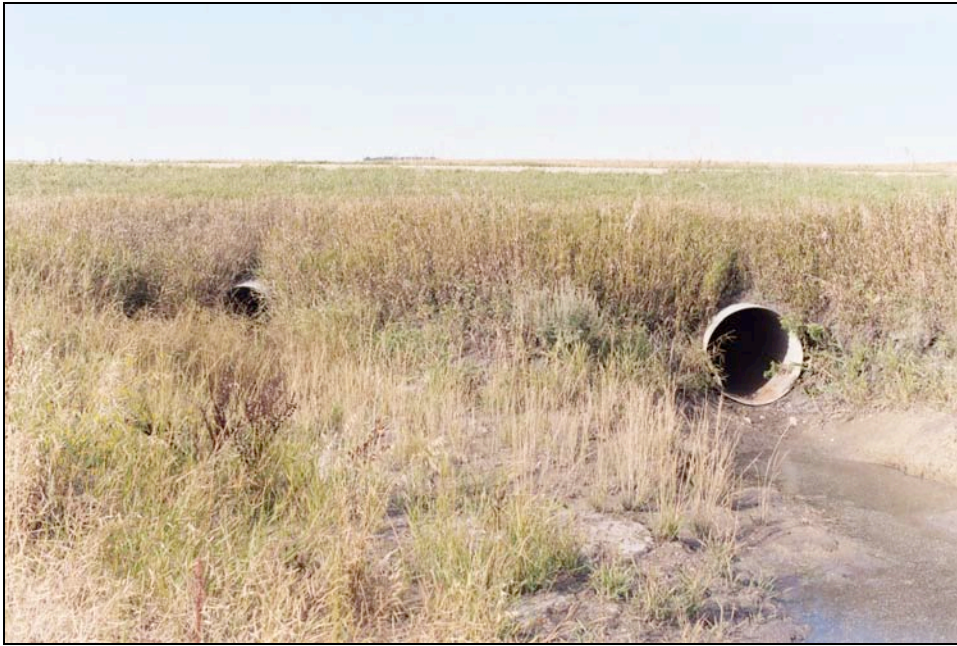
S48 Downstream side of one 24" & one 36" CMPs, in good condition, no water, west to east (09-30-04), Section 12 & 13, T161N, R64W, N 651906.66, E 2389332.46, elevation 1610.9 @ invert of 24" CMP, N 651906.53, E 2389347.98, elevation 1609.6 @ invert of 36" CMP.

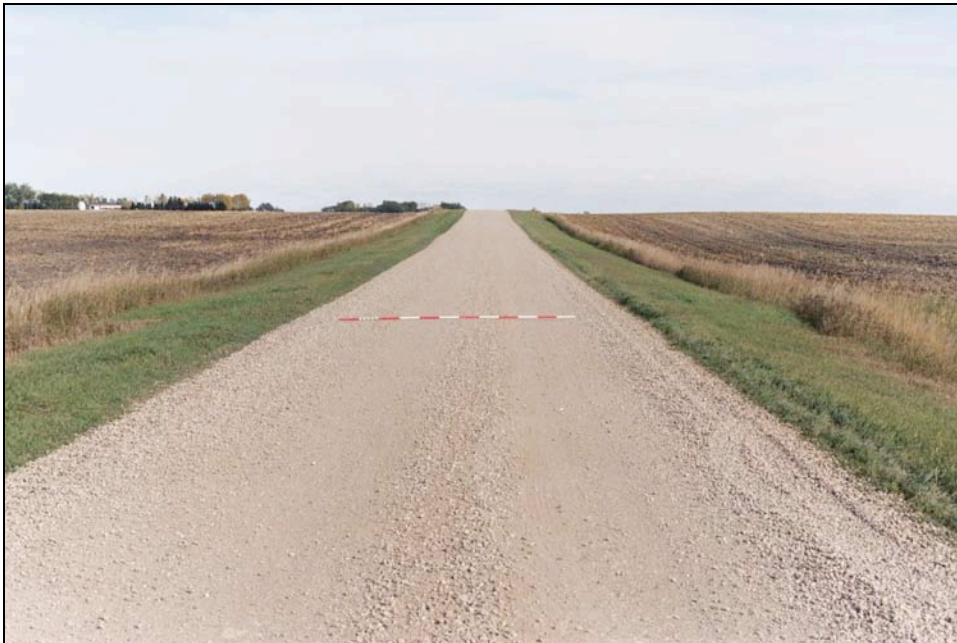
S48 Center of road crossing across one 24" & one 36" CMPs, looking east (09-30-04), Section 12 & 13, T161N, R64W, N 651929.76, E 2389339.04, elevation 1616.7 @ center of road crossing, top of gravel.

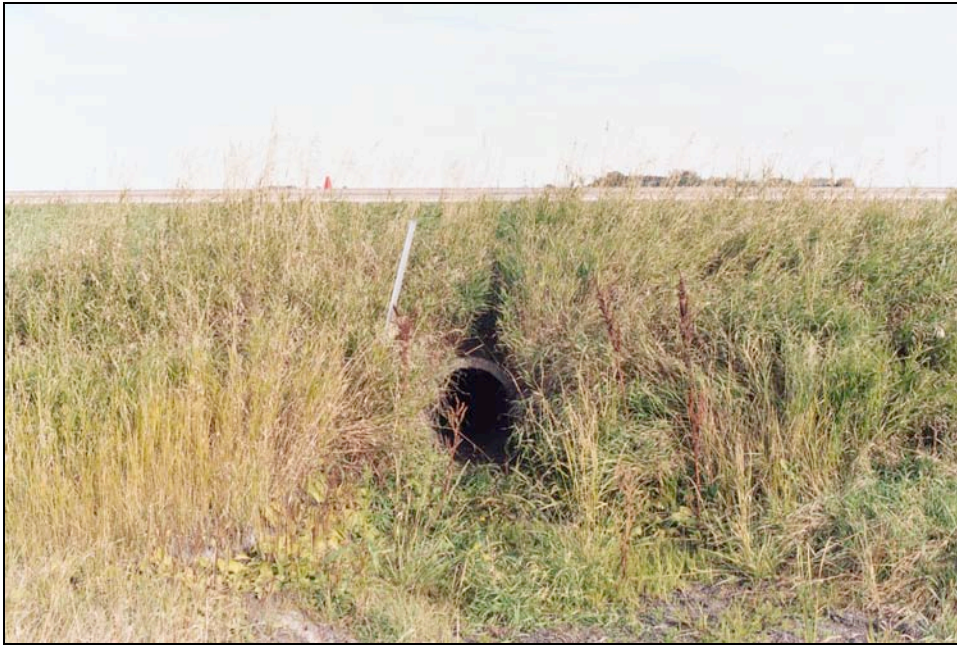
S49 Upstream side of one 24" concrete pipe, in good condition, no water (09-30-04), Section 11 & 12, T161N, R64W, N 653685.15, E 2387931.31, elevation 1612.9 @ invert of concrete pipe.

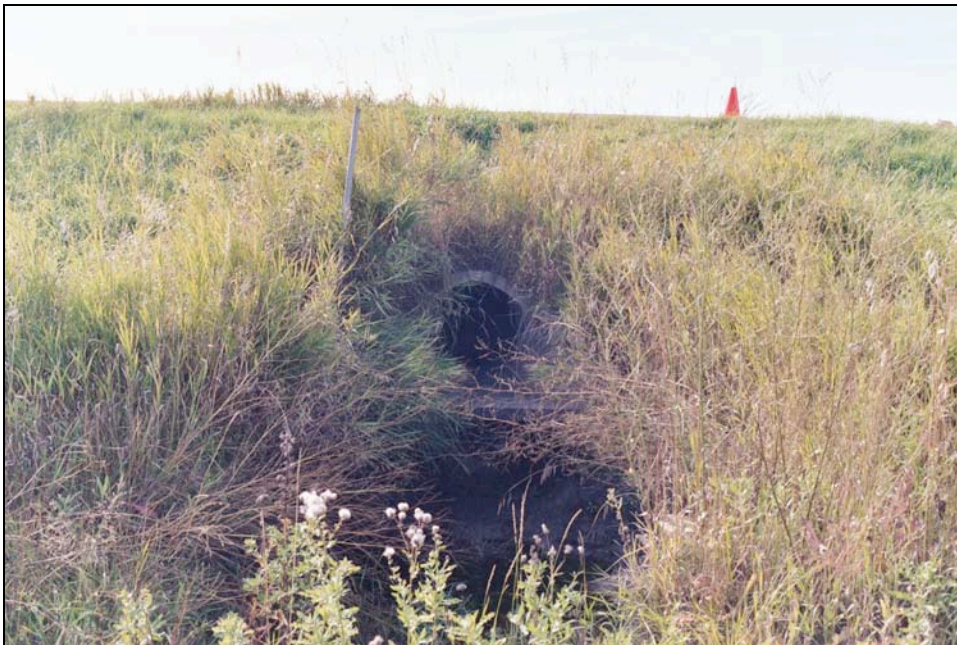
S49 Downstream side of one 24" concrete pipe, in good condition, no water (09-30-04), Section 11 & 12, T161N, R64W, N 653685.92, E 2387985.65, elevation 1612.8 @ invert of concrete pipe.

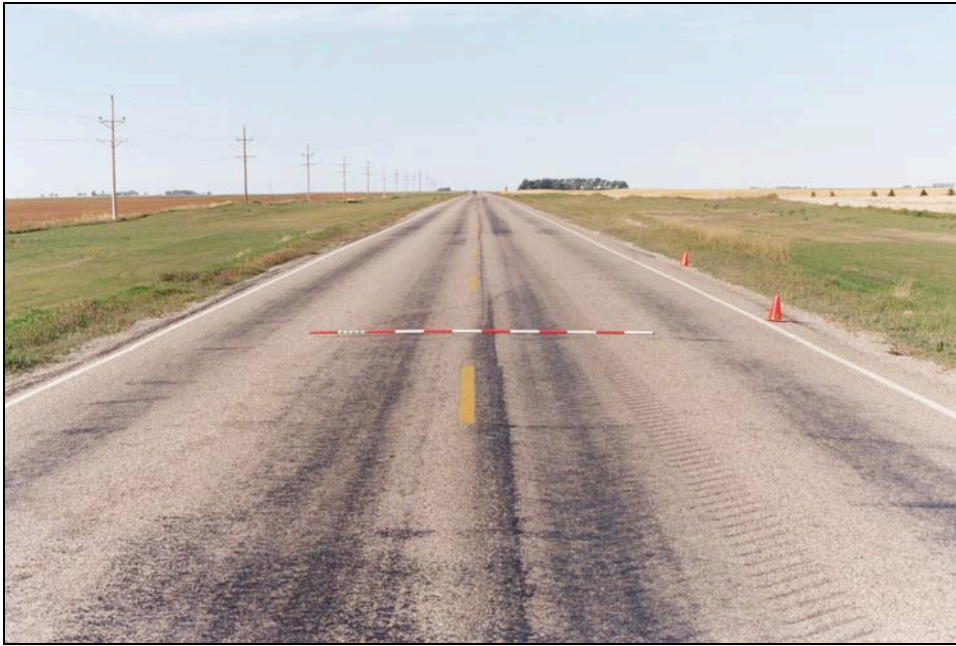
S49 Center of road crossing across one 24" CMP, looking north (09-30-04),
Section 11 & 12, T161N, R64W, N 653685.37, E 2387959.20, elevation 1619.1
@ center of Hwy 5, top of asphalt.
